REPORT OF ENVIRONMENTAL OPERATION

LEAD DOG 1960

PROJECT LEAD DOG 60

A TRAVERSE OF NORTH GREENLAND AND AN AERIAL AND SURFACE EXPLORATION OF PEARY LAND AND CROWN PRINCE CHRISTIAN LAND CONDUCTED BY THE US ARMY TRANSPORTATION CORPS MAY-JULY 1960

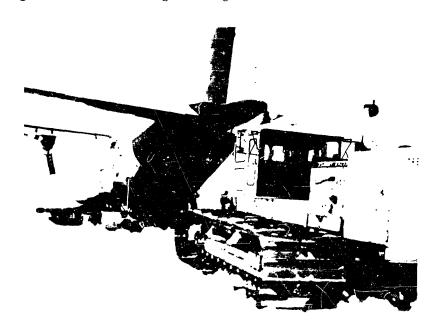
Figure 6. D-8 tractor winches replacement tractor engine from Air Force C-130 aircraft at Mile 664.4. The engine was for the disabled tractor cached at Mile 481.4.

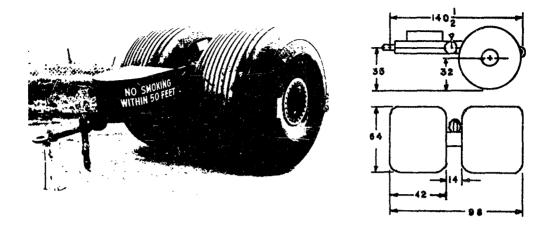
INCIDENT #1: On 7 May, during the initial fueling of the cells prior to the departure of the swing, the spring loaded valve inside the intake disconnect coupling on the right cell of RLT number 0137 failed to seat because of the formation of ice inside the valve. The ice formed around the inside of the valve seat, thus resulting in excessive fuel leakage upon the removal of the valve adapter. The air temperature at the time was $-3^{\circ}F$, the fuel temperature was $+14^{\circ}F$, the wind speed was 15 MPH.

The ice was melted by the application of heat directly to the valve through the use of a 400,000 BTU Herman-Nelson heater. This incident did not occur when the ambient temperature rose above 0°F.

The installation of non-metallic valve seats with corresponding lower thermal conductivity would relieve future occurrences of this nature.

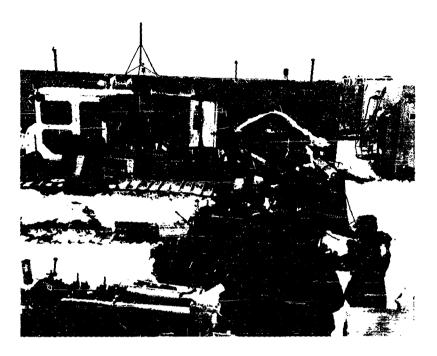
At mile 456.4, on 020415 June, tractor T-1 developed a loud knock in its engine. As the cause of the knock was diagnosed as a cracked crank shaft it became necessary to tow the tractor to Mile 481.4 and cache it for future repairs. The swing was completely refueled and the two navigation Weasels unloaded from their sled. The empty three 10-ton sleds were then cached along with one full sled of diesel fuel for the return trip. The swing was then rearranged to permit the tractors to pull the swing's entire load along with the disabled tractor. Tractor T-2 pulled one sled, one trailer, and two RLTs in addition to the disabled vehicle. After a 12-hour halt the swing moved out in third gear.

Figure 37. Mechanics replace engine in disabled tractor at Mile 481.4.

The swing maintenance personnel began, immediately after the swing's arrival at the junction, to effect the replacement of the engine in tractor T-1. While the mechanics were working on the engine, the remainder of the swing personnel refueled the tractors and RLTs; remade the swing; replaced the rear RLT unit on the Rolli-Trailer (the unit was showing numerous cracks on the inside bead of both cells); performed necessary maintenance on all vehicles; and cached seven sleds, two tractors, three RLTs, one Weasel, and all fuel and supplies not needed for the movement to Mile 124.2P.
